NONCONTACT ASSESSMENT OF HIGHWAY SURFACE VULNERABILITY TO WATER INDUCED DAMAGE

Millar, P., & Woodward, D. (2011). NONCONTACT ASSESSMENT OF HIGHWAY SURFACE VULNERABILITY TO WATER INDUCED DAMAGE. *International Journal of Pavements*, 10(1-2-3), 39-49.

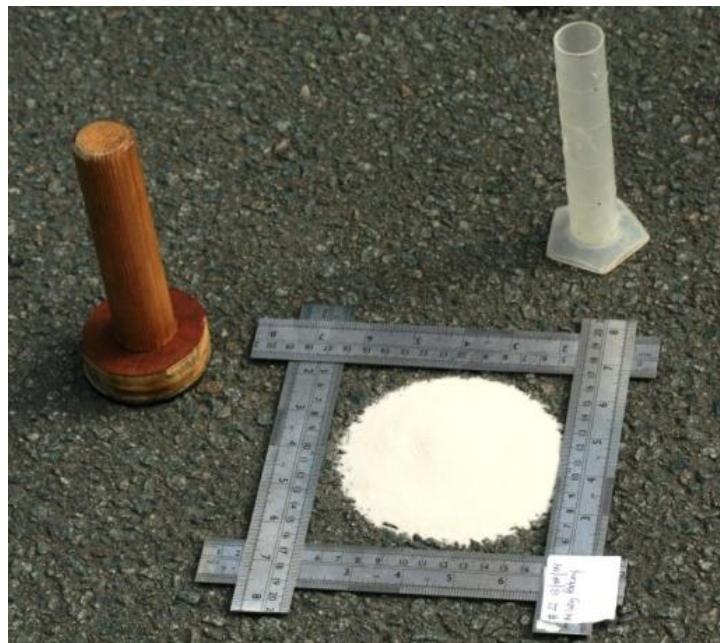
Figure 1: Typical image capture configuration

The simple arrangement of stainless steel rules was used to provide scale for subsequent processing of the stereo images. The orientation of the images is arbitrary as a result but the models can be transformed to simulate camber or crossfall and can be used to generate a theoretically unlimited number of profiles in any direction and orientation. In order to characterize the surfaces, the transformed images were meshed at a 0.2mm interval. A typical surface model is shown in Figure 2.

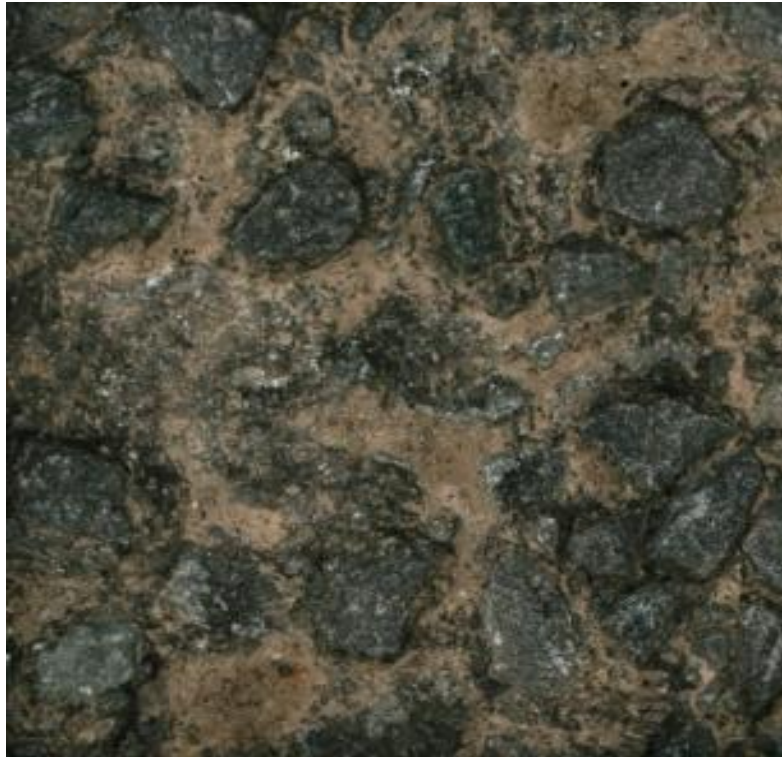
Figure 10. Original digital image of the 14mm chip seal

Elevation frequency distributions such as that shown in Figure 9 are heavily skewed and show distinct peaks. Figure 10 shows the model corresponding to Figure 9 which displays pronounced protrusion of aggregate particles on a heavily trafficked surface. According to Kerr et al. [9] a dataset containing a few extreme values can skew frequency distributions significantly. This can indicate a level of error or bias in some types of research study due to subjectivity introduced by the researcher. As the authors of this study had no influence on the surface relief from which the models were constructed it seems reasonable to conclude that the skew is indicative of some aspect of the surface properties.
